AmeriSpec
PO Box 1411
Deerfield Beach, FL 33442
Ph#: (954) 630-9593

Doc #: 201906 - 04435

Date: 6/19/2019

Dwelling Address:
1234 Palm Circle
Sunshine, FL 98765

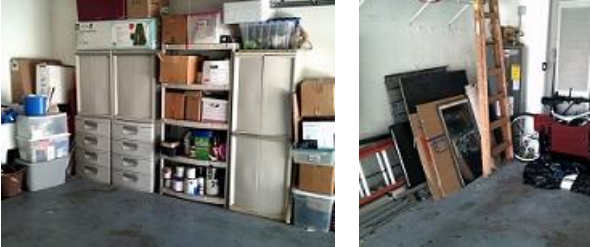
Step #	Component	Comment
1301.	Type	Garage.
1302.	Exterior	See exterior comments.
1304.	Roof	See roof comments.
1306.	Floor/Slab	Serviceable where accessible. Concrete. Common cracks observed.
1307.	Garage Doors	Serviceable where accessible. Metal; Roll-up panel.
1308.	Garage Door Hardware	Serviceable where accessible.
1309.	Door Openers	Serviceable where accessible. Genie; Sears.
1311.	Fire Door	Serviceable where accessible. Wood.
1313.	Fire Wall	Serviceable where accessible.
1314.	Walls	Serviceable where accessible. Paint. Limited review due to personal belongings.

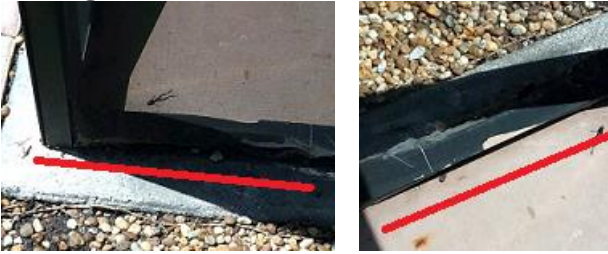
Step #	Component	Comment
1510.	Type/Location	Patio; Located at rear.
1515.	Cover	Serviceable where accessible. Roof.
1517.	Enclosure	Screened. Maintenance. Damaged frame at left side.

1517. Enclosure **Maintenance.**
Damaged frame at left side.

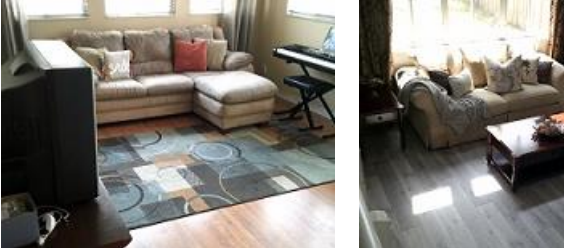
Step #	Component	Comment
2601.	Floors	Serviceable where accessible. Carpet; Wood.
2602.	Walls	Serviceable where accessible. Paint. Limited review due to personal property.
